Technical Report 162

**Removal of alien red mangrove from Kaloko-Honokohau
National Historical Park**

December 2008

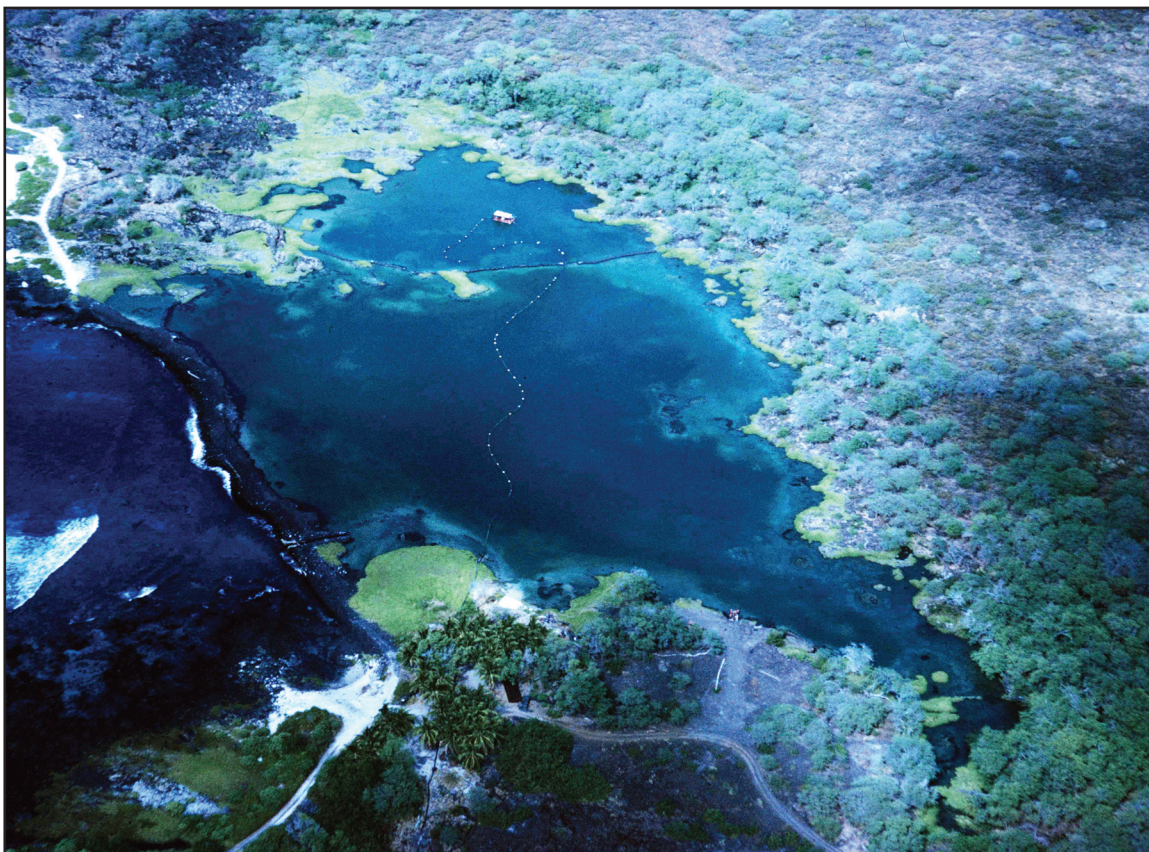
Figure 2. Aerial view of Kaloko Pond, 13 December 1972. The pond is surrounded by typical strand vegetation. No mangrove is present. Archeological site D13-12 (Figures 4 and 5) is in the bottom right corner of the pond.

Prehistorically, ancient Hawaiians converted Kaloko-Honokohau coastal wet sedgeland into fishponds which were then of great economic value. Until the early 1970s, the strand vegetation bordering these pond areas was largely native (Figure 2) consisting of abundant stands of naupaka-kahakai shrubs (*Scaevola taccata*), scattered 10-18 foot high tree heliotrope (*Messerschmidia argenta*), and a few naio (*Myoporum sandwicense*). The strand graded into kiawe (*Prosopis pallida*) and a few milo (*Thespia populinea*) and kou (*Cordia subcordata*) inland. There was a small semi-naturalized coconut grove (*Coco nucifera*) at the south end of the pond. Two endangered birds, the Hawaiian coot (*Fulica alai*) and Hawaiian stilt (*Himantopus medicanus*), used both the ponds as breeding habitat.

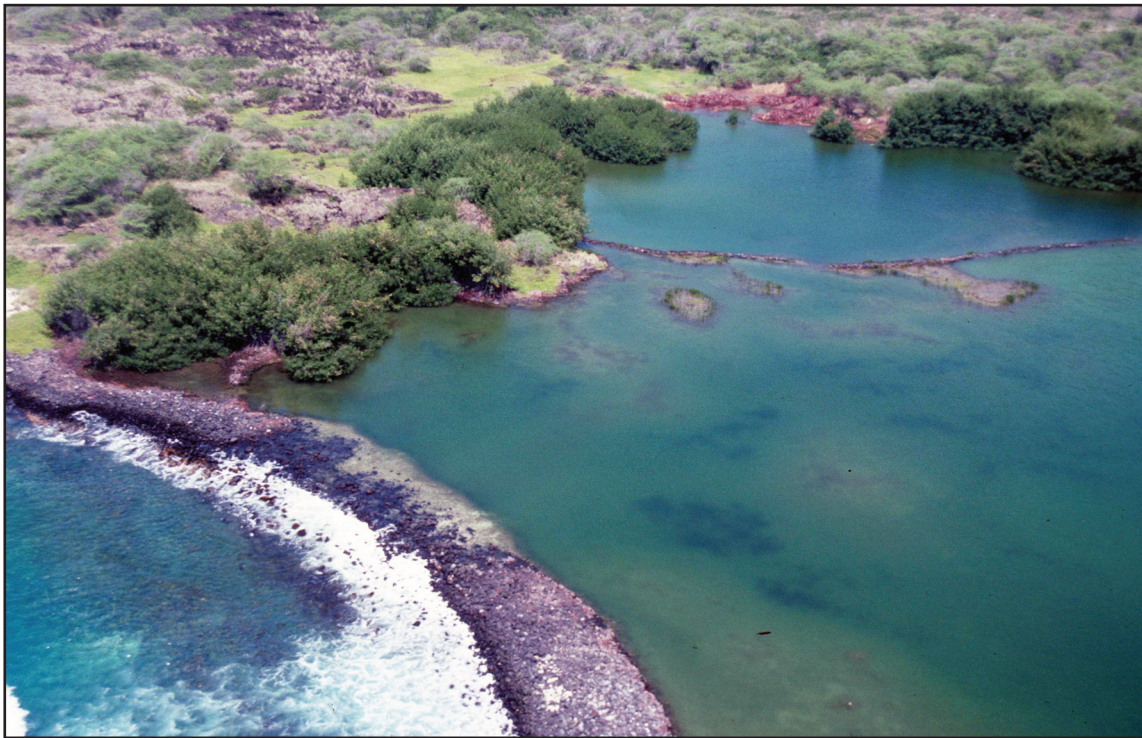
Figure 3. Aerial view of north end of Kaloko Pond, 25 September 1990. Mangrove now had covered the entire shoreline of the pond. Note areas at the main wall in the left foreground, the walls in the pond center, and the upper pond edge where mangrove has been manually removed.

In the late 1970's, red mangrove became established at Kaloko Pond and in the 1980's began to invade Honokohau Pond. The location of Kaloko Pond and areas with mangroves are shown in Figure 1, an early 1990's vegetation map of the park. Red mangrove is alien to Hawaii, and in recent decades it has formed a dominant climax woodland at saltwater swamp sites such as Kaloko and Honokohau ponds. There was no evidence of mangrove at Kaloko in 1972 as shown in the aerial photo (Figure 2). By 1990, as shown in a later aerial photo (Figure 3), solid mangrove thickets have become the dominant shoreline vegetation.

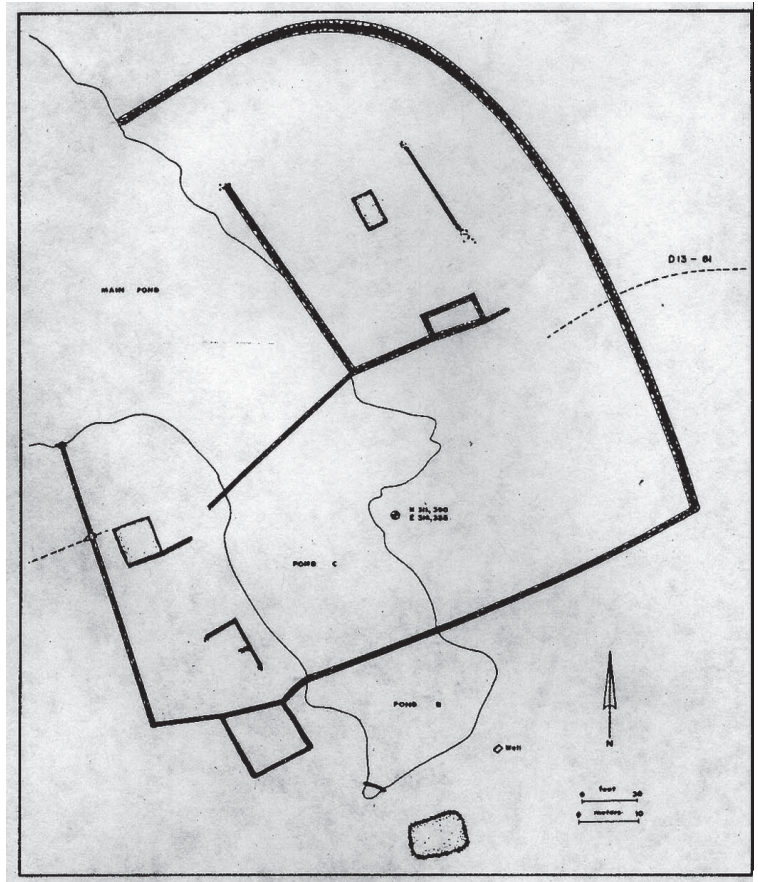
Figure 4. Archeological map by Renger of site D13-12 at Kaloko Pond. This is only one of several archeological sites entirely bordering the pond.

Much of the mangrove infestation, particularly the denser stands, grew upon intricate and complicated archeology features. Renger's archeological map of a site at the southeast edge of the pond, Figure 4, is typical of the entire area with mangroves. Note Renger's further enlarged detail of this site in Figure 5 which highlights the fragile nature of the work site. Mangrove roots penetrated the smallest openings in the ancient ruins and any activity more than careful handwork in removing trees irreparably destroys the old ruins--the principal feature for which this National Historical Park was established.

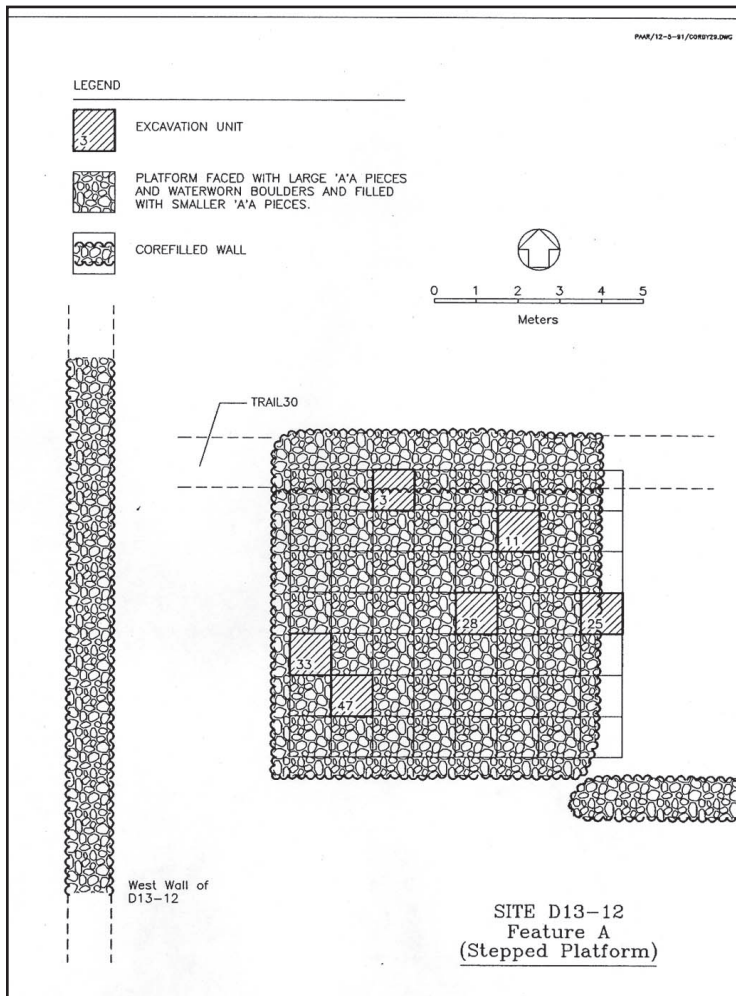
Figure 5. Close-up diagram of a portion of site D13-12 illustrates the detail and complexity which complicated mangrove removal.

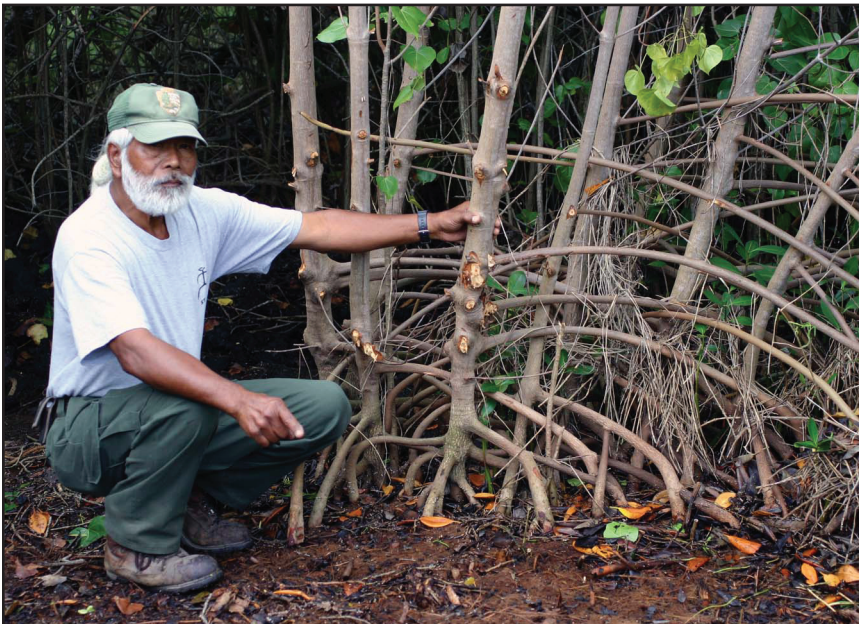
Figure 6. Rizal Fronda's hand is at the level of the initial cut at high tide. At extreme low tide, when this picture was taken, the prop roots are all cut at near soil level. (This picture is at an easy and accessible location).

Park crews effectively killed red mangrove by cutting all trunks and sprouts below the water line or, at least the high tide water line, (Figure 6). The general strategy used relied on a small Boston Whaler decked over with an improvised 8 x 12 foot ramp that protruded about 3 feet beyond the bow. At maximum high tide the Whaler was maneuvered so the ramp pressed against the mangrove trunk. Using a chainsaw the trunk of the main mangrove trunk was cut letting the tree drop crossways on the ramp. Previously, ropes had been laid lengthwise on the ramp for later securing the trees into bundles. Cut trees were compactly stacked on the Whaler ramp in bundles about 5 foot wide and 5 foot deep. One of the ropes was fixed with a hook and eyelet on its ends to form a noose around the bundle for lifting by a front-end loader or helicopter (Figure 8) after the Whaler floated the bundle to a convenient pond staging area for transport to containers for removal to the County dump. By using the Whaler technique, trees were transported by boat and never dragged across archeological features (Figure 9). Where mangroves were inaccessible to the Whaler, crews used a helicopter to transport the bundles rather than scar archeologic features.

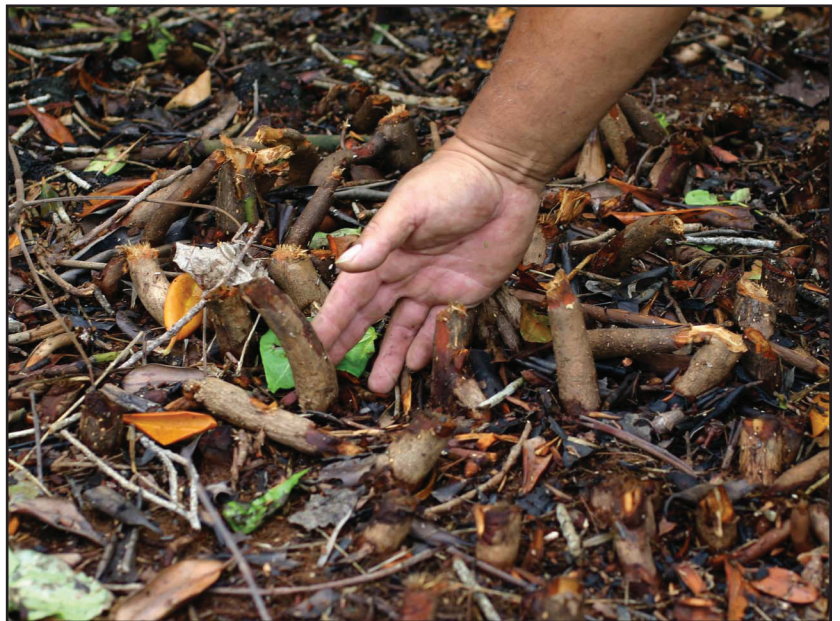
Figure 7. Here the prop roots are cut at near ground level. Treated in this manner the roots do not resprout.

Later follow-up removal of the multiple prop-roots was done at extreme low tide when crews returned on foot to cut each root stalk near ground level (Figure 9). This strategy killed the tree and caused least damage to the archeological sites.

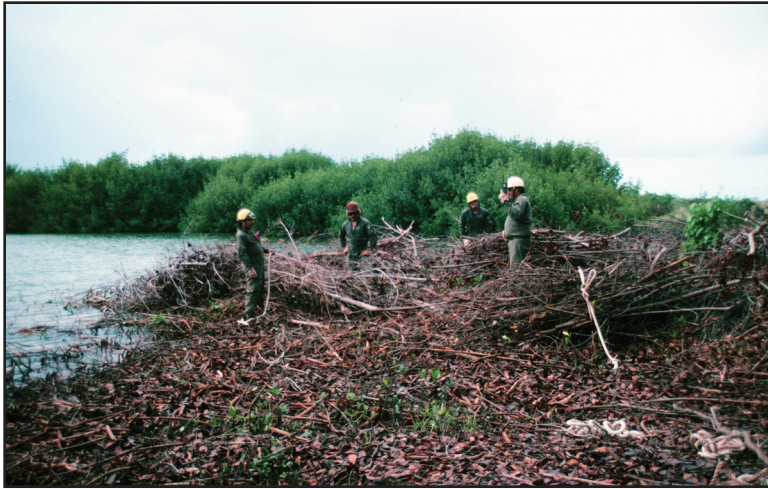
Figure 8. Maintenance crew bundling mangrove cuttings for transport to dumpster loading area.

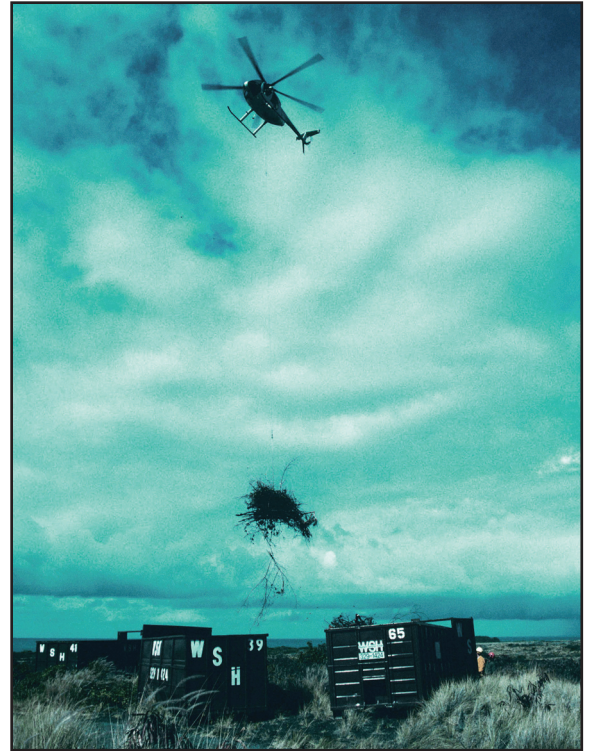
Figure 9. Aerial transfer of mangrove bundle to dumpster for hauling. Kalo Pond 26 December 1990.

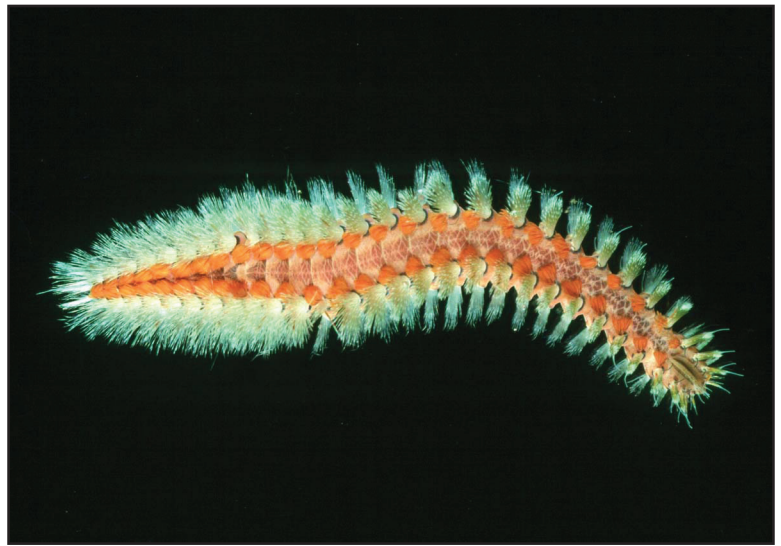
Figure 10. The pond's numerous bristle worms (*Eurythroe complanata*) greatly aggravated manual workers slogging through wetlands to cut mangrove. Bristle worms are notorious for their painful stings.

Use of helicopters and boats require additional safety precautions and operational protocols. Difficult footing made use of chainsaws hazardous. Fireworms were always present and people have different, some severe, reactions to their stings.

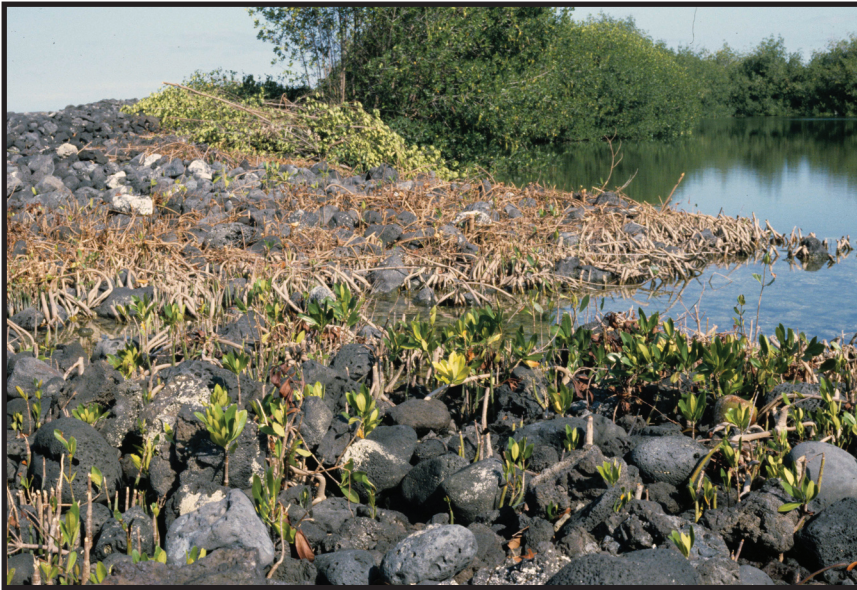
Figure 12. Kaloko Pond foreground shows prolific new mangrove seedlings only a year after clearing. Middle distance is recently cleared mangrove, and in the distance are yet uncut thickets of mangrove.

Neglecting “weeding maintenance” of the controlled mangrove for merely a few years would nullify this control effort and revert the ponds back into mangrove thickets. Though by now resprouting of the old stumps is negligible, there is a constant source of new seed pods floating along the coast from other nearby mangrove infestations; sites over which the park has no jurisdiction. Present maintenance involves annual inspection of all potential habitat searched for mangrove seedlings in the park and either “weed whacking” or burning them out with a methane flame-thrower. At maximum low tide, seedlings are effectively controlled by cutting with mechanical weed whackers as long as the stems are cut below the leaf cluster. Stems too stout to be mechanically cut in this manner are effectively burned with a flame thrower until scorched. This sustained surveillance involves about two to three weeks work annually by a savvy maintenance worker.

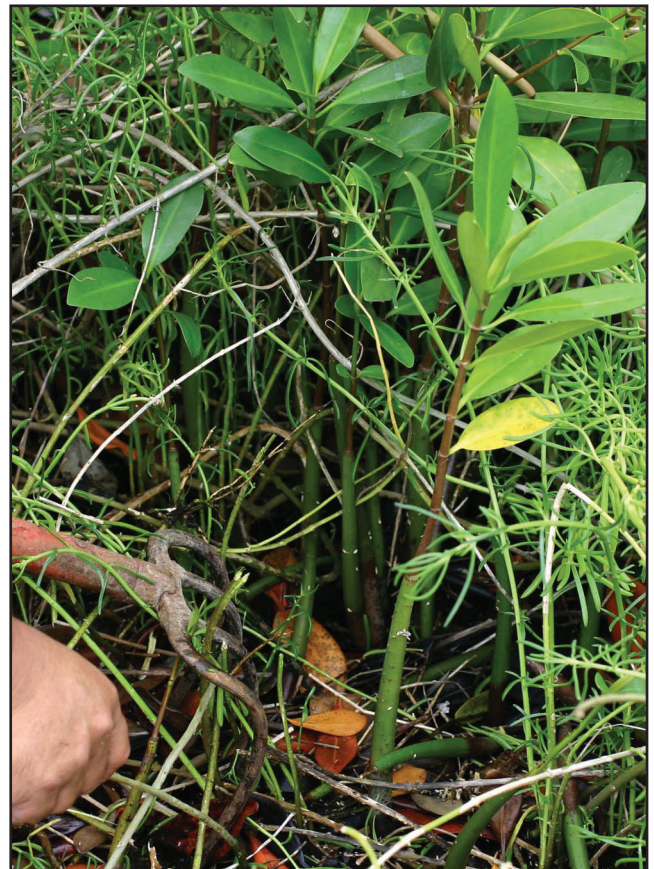
Figure 13. Mangrove seedlings of this size, if completely severed below leaves, usually can be destroyed by weed whacking, and can certainly be killed by a flame thrower.

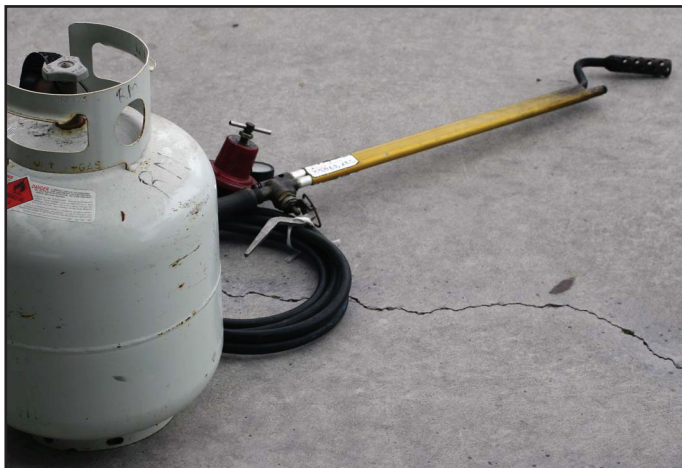
Figure 14. The typical propane flame thrower park crews use to kill mangrove seedlings. Burning sufficient to torch all leaves is effective.

The weedwacking and burning strategies are far superior to techniques such as hand pulling or herbicide treatment. Scorching young shoots and leaves with a propane torch is much quicker and more effective. It leaves no obvious stains on the rocks and causes minimal disturbance because a wide area (some 10 square feet can be controlled from a single position. The operator can easily control areas missed since treated areas are immediately visible.

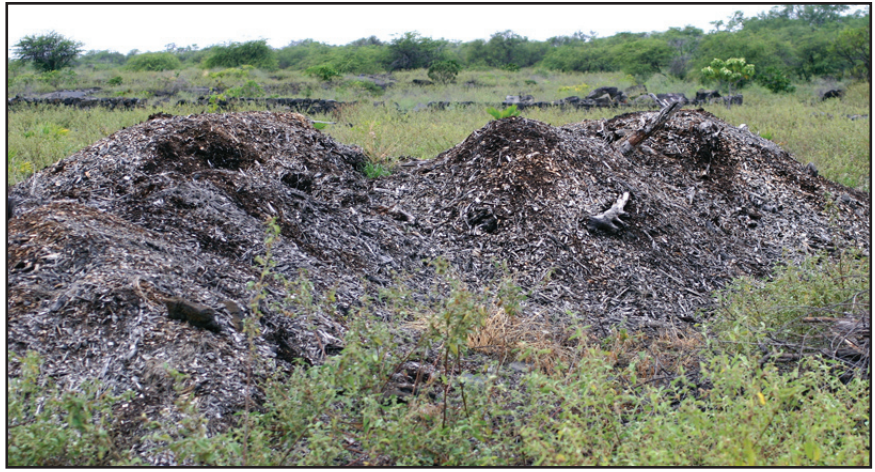
Figure 15. These relict piles of mangrove chips in the park's maintenance yard are only slightly grayer in hue than when stored there there for compost some 18 years ago.

The County dump accepted the mangrove bundles and chipped mangrove during the first few years of the removal program, but later could not accommodate the large volumes. Thereafter the trees were chipped and the chips piled for compost (rather than burned and its prolonged smoke pollution). But mangrove chips are durable—the chip piles remain little decomposed after some 15 to 18 years.
